Descriptive Report with Remarks and Observation Images

Section 14

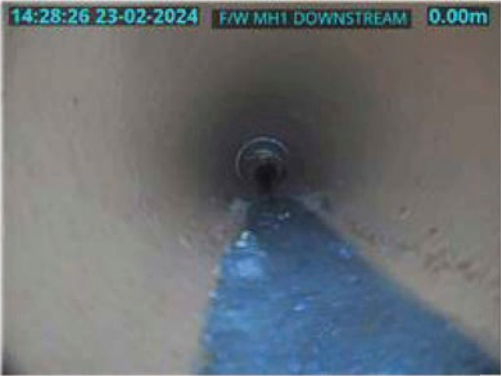
| Pos | Video Ref | Code | Description | Image |
|---|---|---|--|--|
| 00.00m | 0:00:00 | WL | Water level: 0% Height/Diameter | Image Provided - Ref: 13_1 |

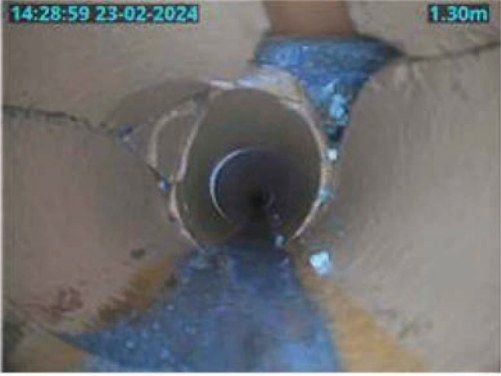
| Pos | Video Ref | Code | Description | Image |
|---|---|---|--|--|
| 01.30m | 0:00:20 | H | Hole in drain/sewer from 12 o'clock to 03 o'clock - Severity 4 | Image Provided - Ref: 13_4 |

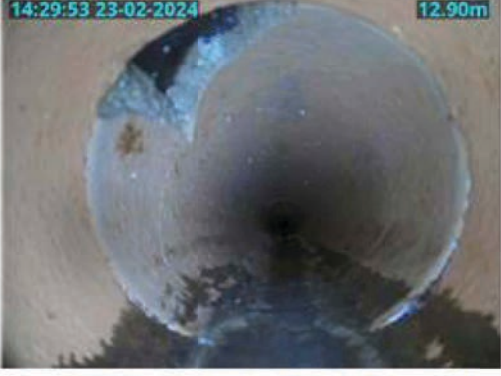
| Pos | Video Ref | Code | Description | Image |
|---|---|---|--|--|
| 12.90m | 0:01:08 | H | Hole in drain/sewer from 10 o'clock to 12 o'clock - Severity 4 | Image Provided - Ref: 13_5 |
